Improving Mill Productivity with Advanced Wear Protection Solutions

Port Alberni mill extends boiler ID fan life, outage cycles with advanced wear protection.

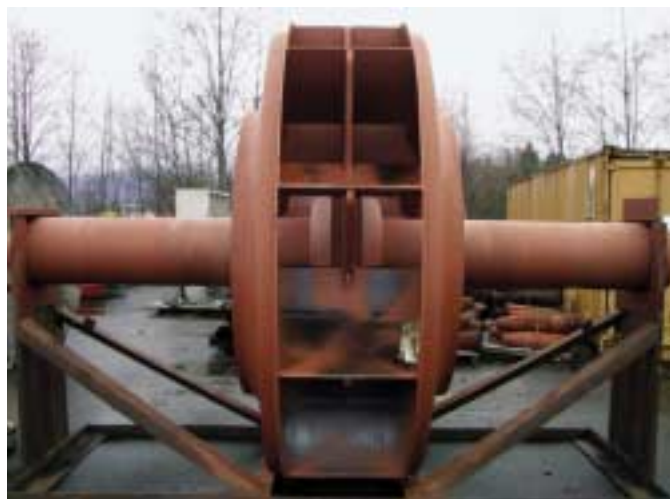
Figure 1. Port Alberni's power boiler ID fan.

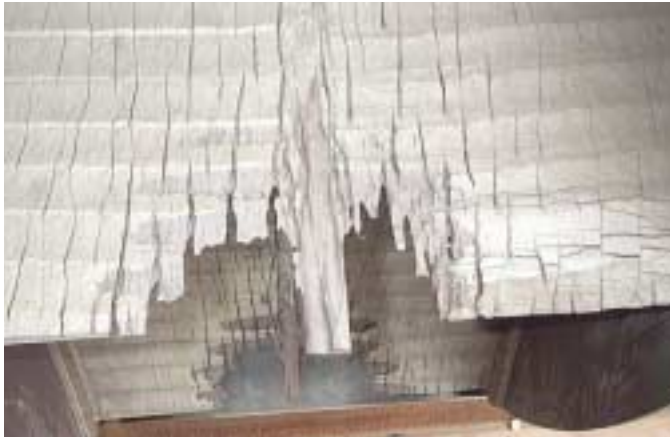
Figure 2. Fan blades protected by chrome carbide weld overlays after 12 months in operation.

bide weld overlays to protect the ID fans from abrasive wear. During typical fan operation, however, fine particles eroded through the hairline cracks inherent to hardface weld overlay materials. These cracks provided a less resistive path for erosive materials to wear through the overlay. Portions of the chrome carbide were undercut and began to detach from the fan, as shown in Figure 2.

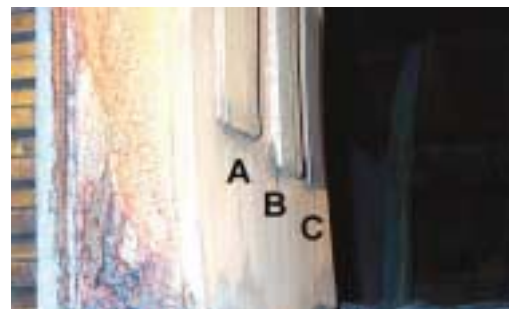
The tested wear protective materials were compared in December 2001, after six months of ID fan operation (see Figure 3). The brazed tungsten carbide cladding outperformed both the low alloy steel and the chrome carbide overlays. Only the tungsten carbide cladding retained its original length, as shown in Figure 4. Due to the success of the sample brazed tungsten carbide cladding, the mill covered portions of the ID fan blades with clad liners during its next annual shutdown.

Figure 4. Comparison of material lengths after six months: (A) alloy steel, (B) chrome carbide weld overlay, (C) brazed tungsten carbide cladding.
